Report No.: LCS200903017BS

TEST REPORT

Dust test for first characteristic numerals 6

Test for second characteristic numeral 7: temporary immersion between 0,15 m and 1 m

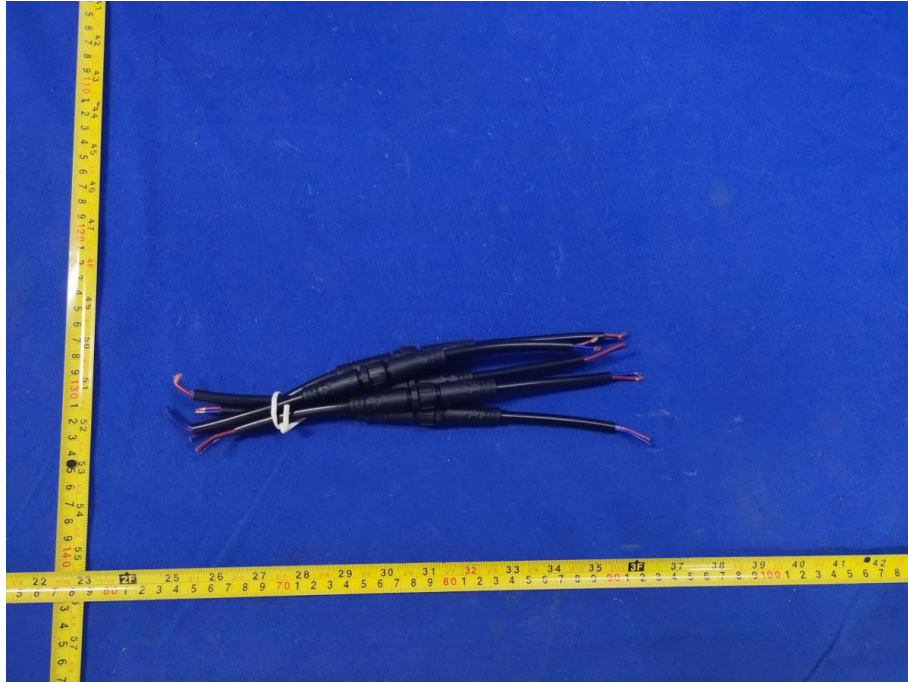
Photo 1: Overall view of model CONNECTOR II

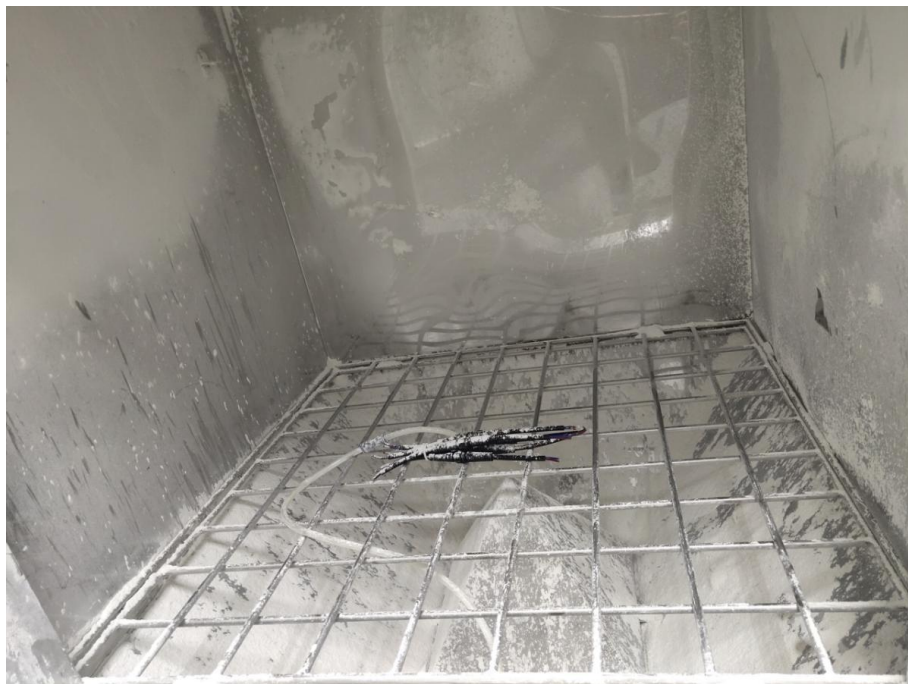
Photo 2: IP6X test of model CONNECTOR II

The enclosure under test is supported inside the test chamber and the pressure inside the enclosure is maintained below the surrounding atmospheric pressure by a vacuum pump.

The protection is satisfactory if no deposit of dust is observable inside the enclosure at the end of the test

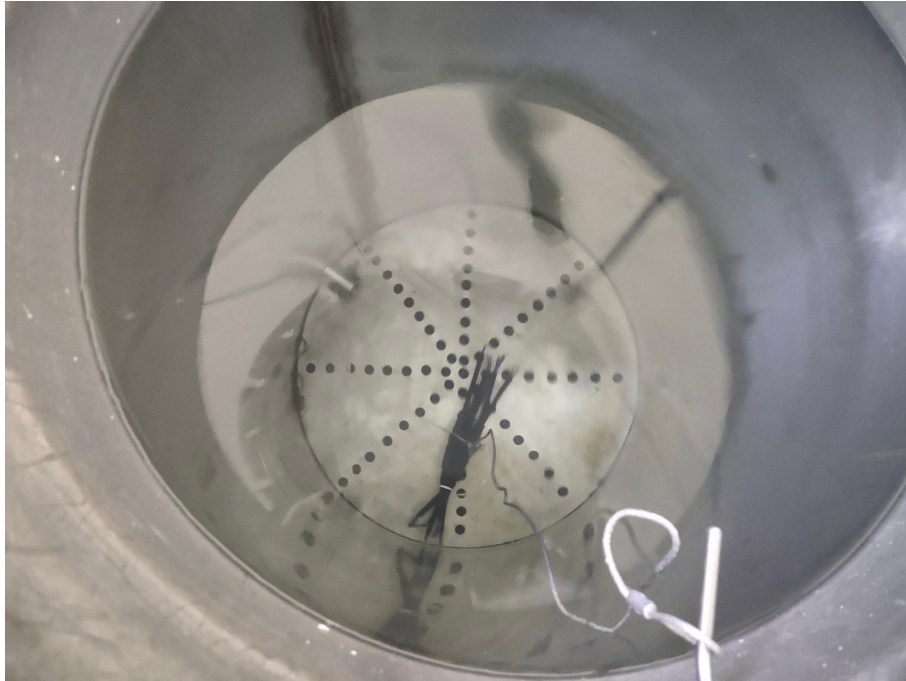
Photo 3: IPX7 test of model CONNECTOR II

The test is made by completely immersing the enclosure in water in its service position as specified by the manufacturer so that the following conditions are satisfied:

- a) the lowest point of enclosures with a height less than 850mm is located 1 000mm below the surface of the water;
- b) the highest point of enclosures with a height equal to or greater than 850mm is located 150mm below the surface of the water;
- c) the duration of the test is 30 min;
- d) the water temperature does not differ from that of the equipment by more than 5 K.

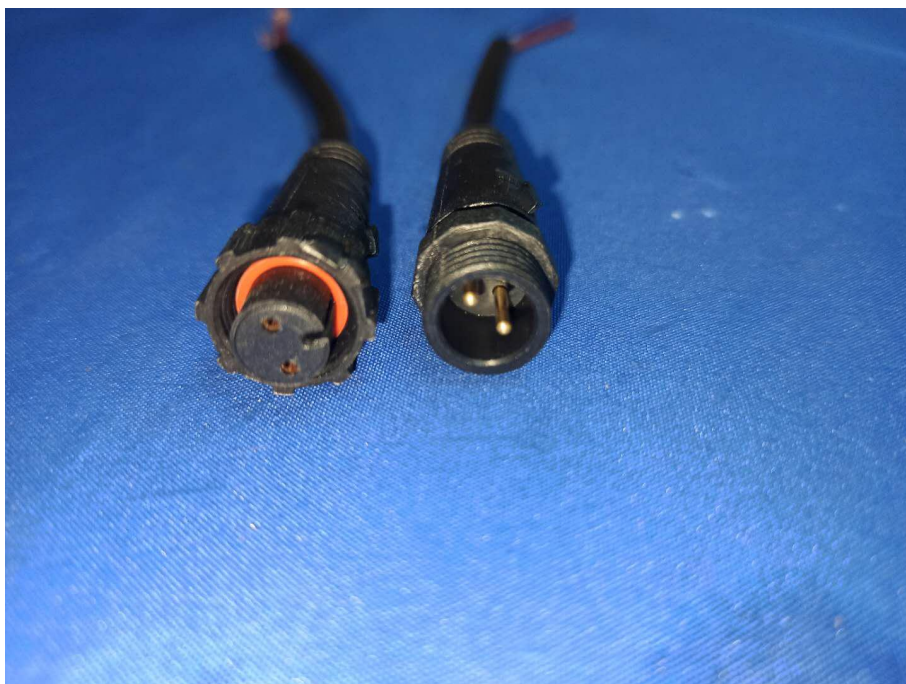
Photo 4: Test result after IP6X and IPX7 test
